Effect of Non-Point Source Runoff and Urban Sewage on the Yaque del Norte River, Dominican Republic

Peter Phillips - Department of Biology  
Winthrop University, Rock Hill, SC 29733  
Arturo Russell - Pontificia Universidad Católica Madre y Maestra  
Santiago, Dominican Republic

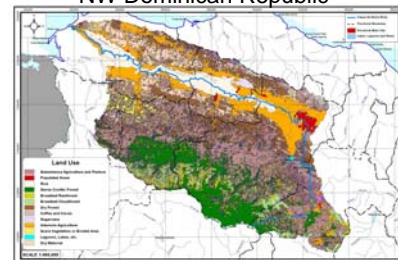
Land use in the Yaque del Norte watershed, NW Dominican Republic

- Watershed contains 7,000 km<sup>2</sup>, or 14% of Dominican territory.
- Originates in the Central Cordillera.
- Discharging into the Atlantic Ocean near Haiti.
- Northern boundary enclosed by the Northern Cordillera.
- Watershed elevations range from 3,000 m to sea level.
- Watershed population is 1.3 million.

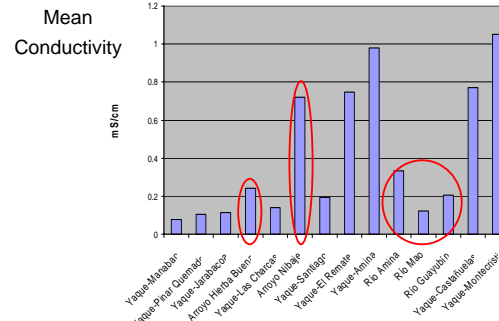
- Electrical conductivity was lowest in the high watershed and upper reaches of the mid-watershed, ranging from 0.08 to 0.19 mS/cm.
- Mean conductivity in Arroyos Hierba Buena and Nibaje was significantly higher (0.24 and 0.72 mS/cm, respectively) than mainstream river waters.
- Downstream of Santiago, conductivity increased substantially to a high mean of 1.05 mS/cm.
- Circled bars are tributaries to the river mainstem.
